Manhole Inspection Summary

Manhole # S47G__023MH

Insp Date: **7/9/08 11:22 AM**

Location Address: **Pratt**

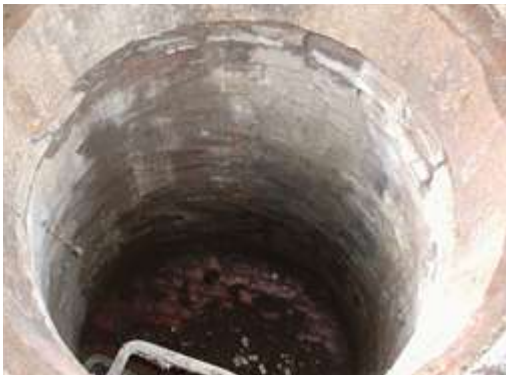
Defect 1

Frame Offset: **0.5** (in.) Condition: ☐ Sound ☐ Cracked ☒ **Leaks**

frame leaks

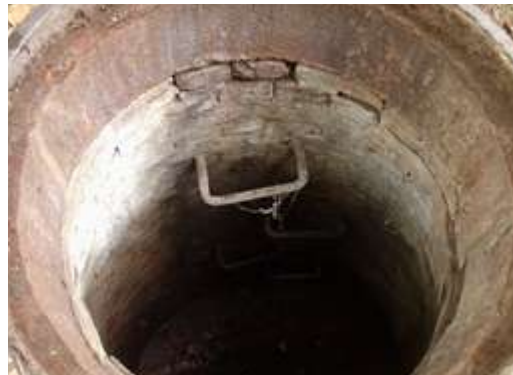
Defect 2

Condition: ☐ Sound ☐ Cracked ☐ Root Intrusion ☒ **Loose Brick** ☐ Deteriorated

loose brick

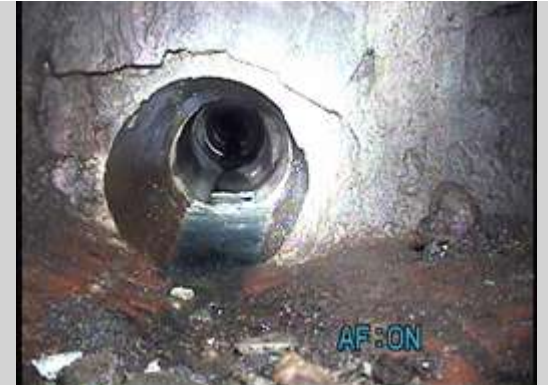
12 O'Clock Outflow

8 in. Circular Gravity Sewer
Pipe Out @ 12 O'Clock

Infiltration: **None** Pipe Seal Cond: **Sound**
